BRAWLEY WASH NATURAL RESOURCE RESTORATION PLAN

Pima County, Arizona

June, 1992

**PREPARED BY
USDA, SOIL CONSERVATION SERVICE
PROGRAM PLANNING STAFF
Phoenix, Arizona**

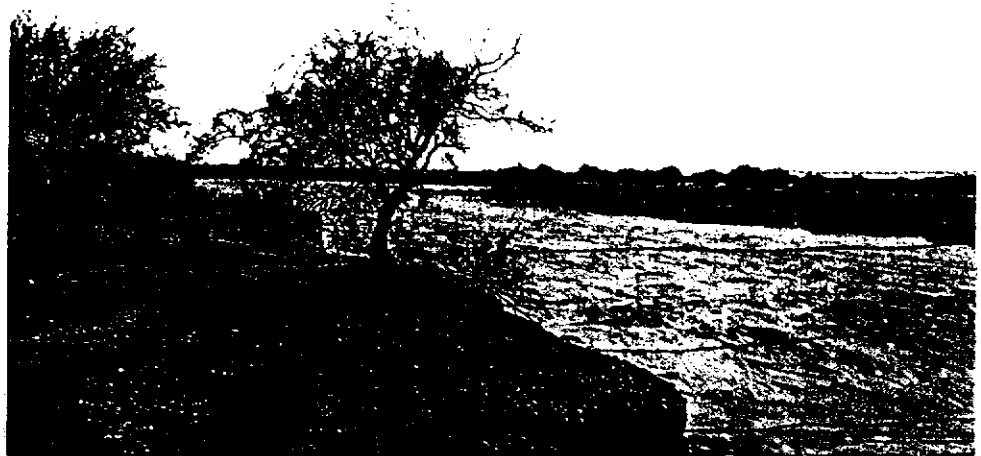
October, 1983 (middle) before erosion. Result of bank erosion (bottom left). Photos were taken at the Anvil Ranch Crossing.

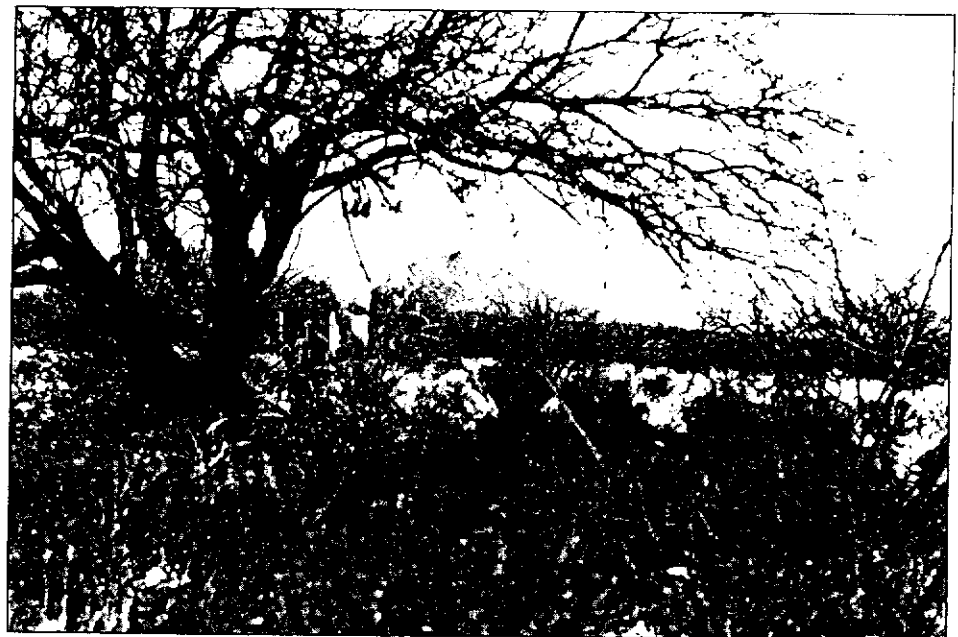
In 1893 desert grassland occupied the area at Boundary Monument 144 (top). By 1983 shrubby species had spread and thickened.

Streambank erosion and the associated lowering of the water table and base floodplain has also removed riparian vegetation and limited further riparian habitat establishment and growth.

The year 1920 probably saw the start of the large scale change of the valley's flora from grasslands to shrublands (Bryan, 1925). Burroweed and snakeweed were indigenous to at least the northern quarter of the valley prior to settlement. It was not until the early 1940's that they had moved as far south as the Elkhorn-Las Delicias Ranch area. The spread and thickening of these two species is very simply due to the continuous past grazing whereby forage species were slowly removed and these toxic species were able to occupy the vacant space left (Robinet, 1981).

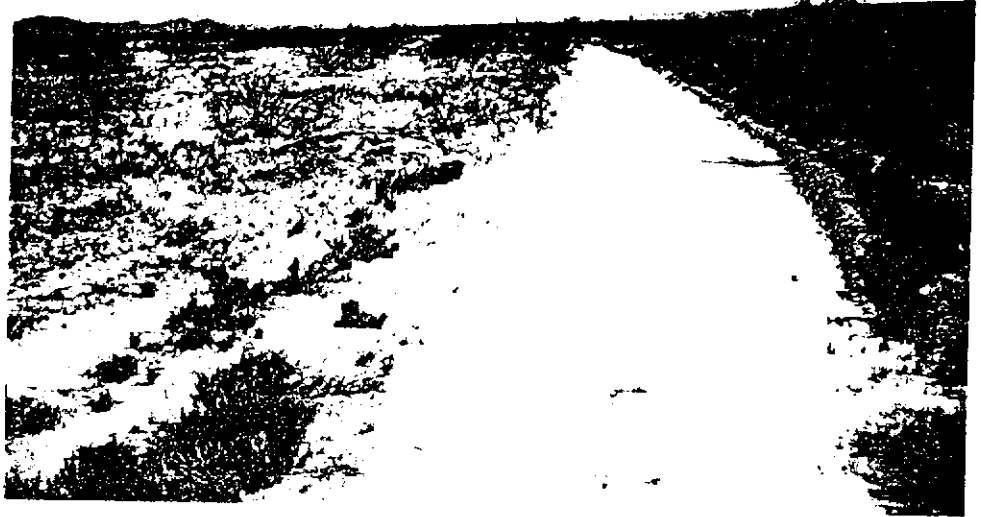
Prescribed burning on the West Mill Pasture, June, 1985. First summer after prescribed burn (Oct. 1985) (top). Site after second summer (Oct. 1986). (bottom).

The first burns done in cooperation with the Buenos Aires Ranch and the Arizona State Land Department occurred in 1978. Burns were done in May and June to remove burroweed and snakeweed and top kill mesquite, allowing perennial grasses a chance to reestablish. On one of the larger ranches in the northern part of the watershed, a prescribed burning program which began in 1985 has resulted in over 13,000 acres of actual burned land in four pastures totaling about 20,000 acres. The resulting treatment has left a mosaic of grasslands, shrublands, and tree-lined washes and has been a tremendous help to wildlife, recreation, watershed, and ranching values. It is estimated that 175,600 acres of the watershed still need some brush management to reduce the density of mesquite.

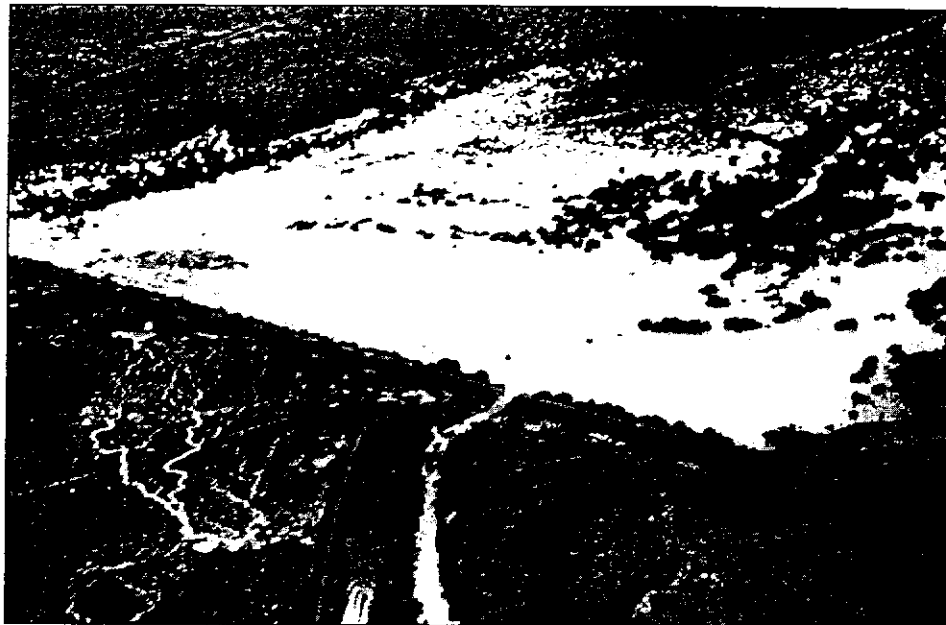
The Bureau of Land Management "Fan Structure" in the San Simon Valley during the 1983 flood

structed which was designed to catch sediment and restore the incised wash to its original floodplain. Today this structure has graded the floodplain for a length of 10 miles and trapped approximately 19 million tons of sediment. This concept of erosion and sediment control also applies to the Brawley Watershed which is in an actively eroding state. Retaining the sediment produced along with vegetative management of the rehabilitated, sediment filled area will promote regrading of long reaches of the incised wash and its tributaries.

The Pima NRCD has pointed out a solution that has been installed for similar problems on the San Simon watershed in southeastern Arizona. In 1953 the first of a series of grade control structures was con-

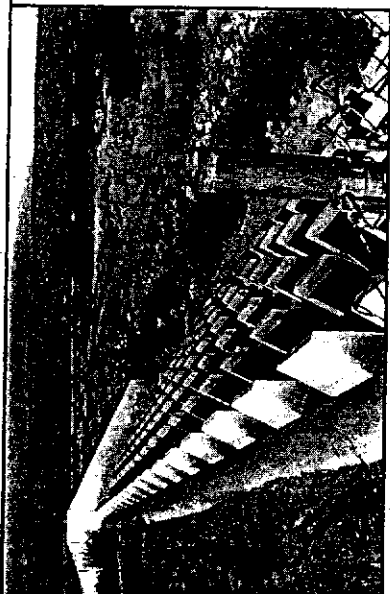
baffle chute used for the "Barrier" structure in San Simon Valley.

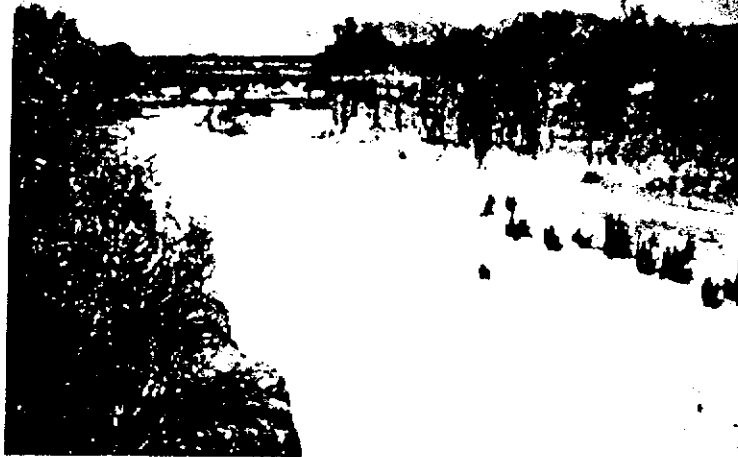
Existing incised wash (top) and a computed generated image of the same area based on the installation of a grade control structure and vegetative management (bottom).
