**Elkhorn / Las Delicias
Demonstration Project:
Planning, installing and monitoring watershed
restoration practices in ephemeral arroyos and
associated uplands in a flash flood dominated
landscape, Altar Valley, Pima County, Arizona.**

February 2014

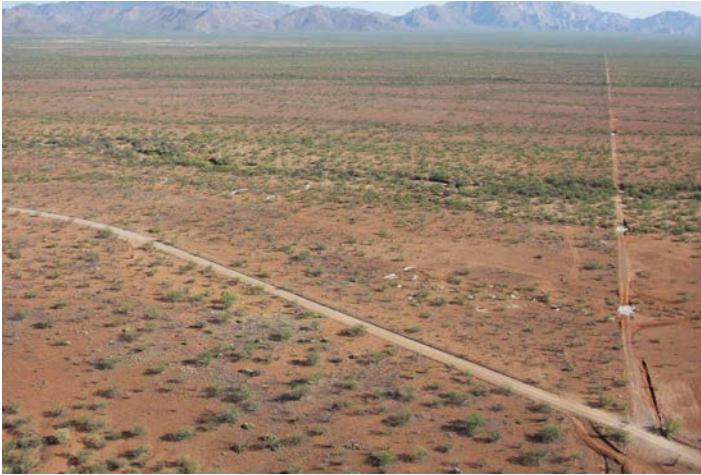
Figure 1. Aerial view showing intersection of Elkhorn Ranch and fence-line access roads.

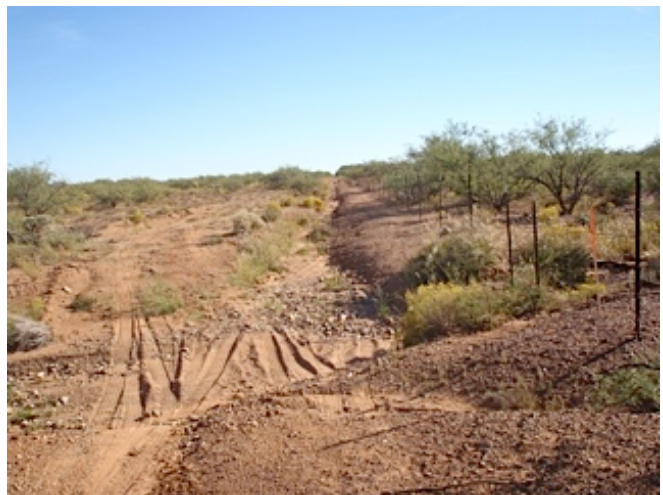
Figure 2. Incised fence-line road that triggered extreme watershed degradation at the Elk/LD Demo site.

Over time, the fence-line access road became incised due to water becoming trapped in the road. In addition, as road conditions deteriorated, vehicles made new routes, thus increasing road width. The increasingly wide and deep fence-line road interrupted and captured water sheet flow. Water caught in the road was then released into the natural drainage channels at higher volumes than the natural capacity of the channel. Increased water volume encouraged channel incision. There is also evidence of bulldozer work to “smooth out” eroded crossings by pushing rough soil and rock out of the channel so that vehicles could pass, thus further deepening the stream channel. As these channels became deeper and deeper at the road crossings, the channel incision began to march upstream in the form of “head cuts”. The combined effects of past land use and the road caused serious channel incision problems in numerous channels, as well as related tributaries, and these effects were heading upstream.
