San Simon Valley Tour
2015
Provided to AVCA by Larry Humphreys

Background Information

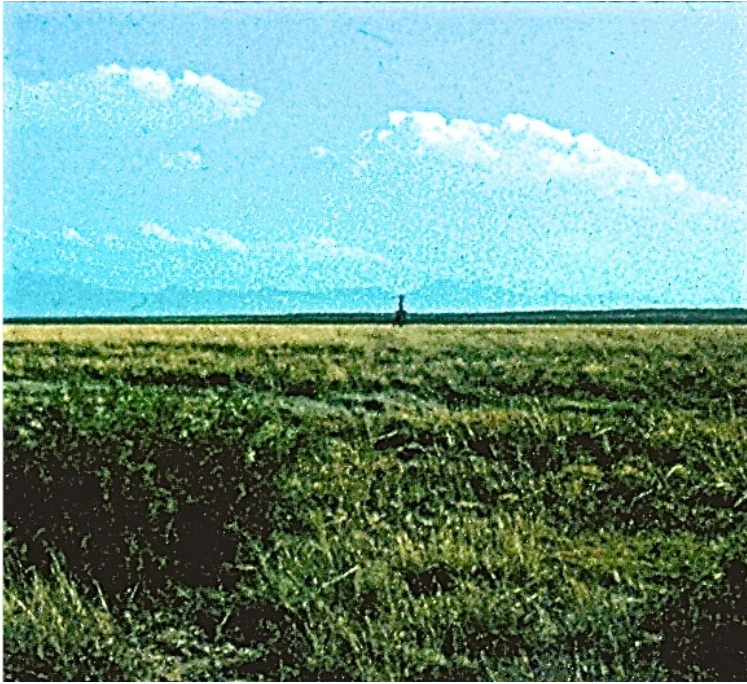
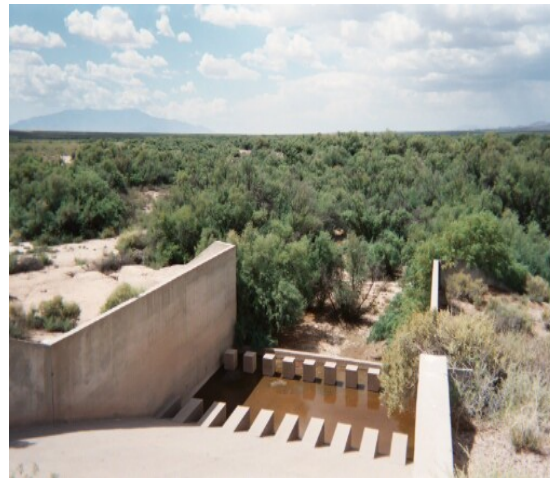
Stop 1. Contest Well

This 600-acre seeding to a depth of 18 inches dense stand of mesquite 1966 it was aerially Blue Panic grass and This seeding is located that has filled in behind Fan Structure. The prevented the reinvasion the area has been Johnson grass. This periodic flooding and highly productive since was built, producing up to 9,000 pounds of air-dry forage per acre. It also provides habitat for mule deer and javelina, and supports a prey base for raptors. Cottonwoods and willows have been planted to provide perches and nest sites for raptors.

was root-plowed to eradicate a and salt cedar. In seeded to Giant Bermuda grass. on the sediment the San Simon seeding has of salt cedar, but invaded by seeding receives has become the Fan Structure

The 600-acre seeding provides six-month winter grazing for up to 170 head of cattle. Prior to Fan, only 4 to 6 head of cattle could graze the same area. During the summer months, the seeding is rested and conditions are favorable for a large buildup of rodent populations. In winter, the rodent escape cover is grazed off and the rodents are susceptible to predation by migrating and wintering raptors in the area.

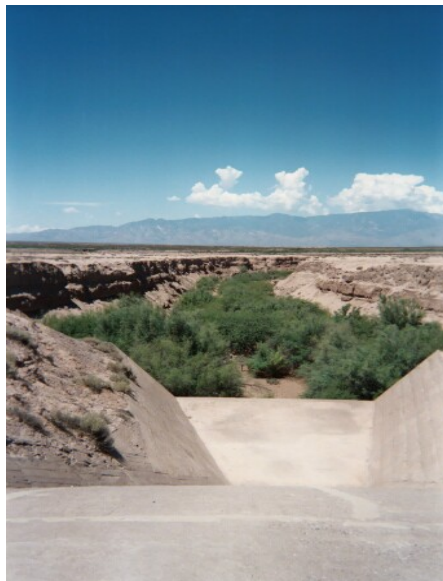
Stop 2. San Simon Fan Structure

The Fan
Soil
out in 1954 and
\$271,000. As a
eroded channel
upstream.
evident for over
completed in
had trapped 19
completion. The
management
channel is
head of cattle

Structure was built in 1953 by the
Conservation Service. It washed
was rebuilt in 1955 at a cost of
result of the structure, the formerly
has been filled for 44,000 feet
Evidence of channel regrading is
10 miles upstream. Studies
1989 revealed that the structure
million tons of silt since its
area is included in an allotment
plan for livestock and the regraded
capable of supporting about 150
per section for six months.

From strictly a mechanical or engineering standpoint, the dam should have affected the channel for only a few thousand feet upstream but vegetation established above the dam allowed floodwaters to slow down farther and farther upstream and drop their silt load, causing the effects of the dam to be magnified upstream.

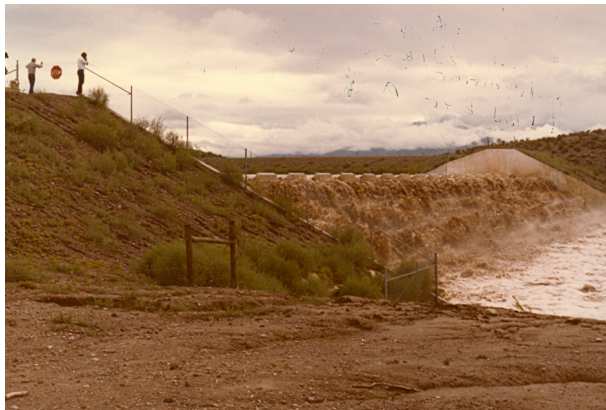
San Simon Barrier, October 1983

Built in 1980 by BLM for erosion control and watershed rehabilitation of the San Simon Valley, construction cost was \$1,300,000. The structure contains 224,000 cubic yards of compacted earth fill and 2,684 cubic yards of reinforced concrete requiring 313,000 pounds of steel.

Within the first two years, the channel silted in to the level of the spillway (17 feet). To date, the channel has been completely regraded for 1,900 feet upstream and effects of the structure can be measured for over 19,700 feet upstream. The dam has trapped, as of 1989, over 4 million tons of silt. Although not specifically designed for flood control, this dam and other dams on the watershed reduce peak flows and protect the town of Solomonville and nearby farmland.

Starting in 1982 and continuing for several years, about 500 cottonwoods and willows were planted within the floodplain. For the first 10 years, about 50 percent survived during the wet period of the 1980s and early 1990s. With the onset of drought, most of the surviving trees have died. In 1983, about 30 acres were root-plowed, disked, and seeded to replace invading seep willows and salt cedar with more desirable species. The goal is to eventually have the floodplain exhibit a mosaic of about 80 percent grasses and 20 percent riparian trees and shrubs. The rehabilitated area (about 300 acres) was excluded from livestock grazing for over 10 years, but livestock are now allow to graze the area. The area provides excellent habitat for mule deer, javelina, dove, and quail.
