Put your money where success has been – a rapid review of interventions to improve pastoral land condition in the southern rangelands of Western Australia

Penny, NR¹; Williams, AR²

Key words: regeneration techniques, evaluation, WA Goldfields

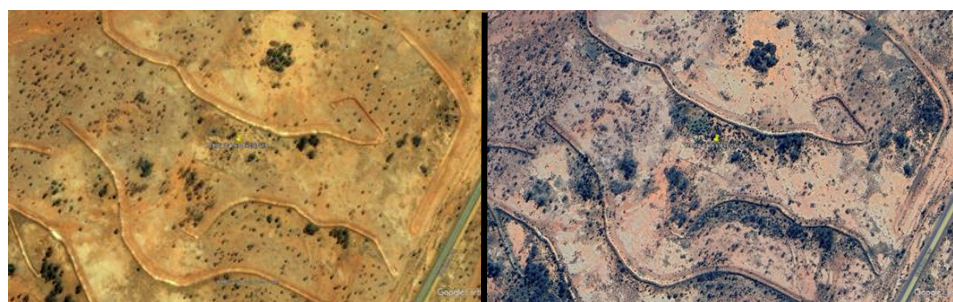
Fig 1. Centre of Melita 'Big Banks' system. Google Earth images in April 2005 (left) & July 2024 (right)

We visited bulldozer-built banks at Melita and Sturt Meadow Stations. The Melita banks were designed and supervised by John Law to reduce erosion and rehabilitate the area by impeding runoff and increasing soil infiltration. An explanation is provided in Law 1993. The work was a collaboration between the mining industry, pastoral industry and government. One of the first changes attributed to the banks was increased aquifer recharge. This caused Heron Well on the east side of the highway that had been dry for a long time to start producing water again (John Law, pers. comment). Of the interbank areas, the banks decreased the length of slope for all locations typically increasing the stability of soil surfaces and vegetation density. The banks caused water ponding for approximately 5% of the overall area. This varied between interbank areas from less than 5% to up to 25%. Ponded areas experienced the greatest increase in vegetation density and size. It has taken several years before the banks have started to show their benefit. This was partly due to feral goat grazing some years ago (Jim Addison, pers. comment). Remote sensing scenes of the banks from April 2005 and July 2024 show a great improvement in the cover by native plants, particularly Mulga and halophytes (Fig. 1). Plants near the bank were twice as tall as those further away and had more than double the canopy area.
